Sean Moss Home Inspection Services

Property Inspection Report

2580 Anywhere Lane, Somewhere , BC, V6H 2L9

Inspection prepared for: Henry Sample
Inspection Date: 12/19/2010 Time: 1:00 PM
Age: 50 Size: 2500 SF
Weather: Clear & Sunny

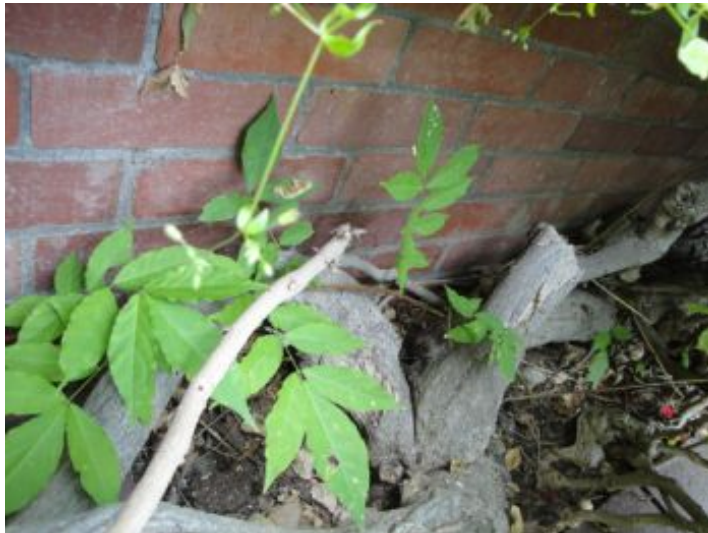
- Vegetation has grown too close to the exterior.

Vegetation is too close to the exterior

Recommendation: Trim or prune all vegetation a minimum of one foot away from the building. This is necessary in order to prevent moisture damage to the exterior and to inhibit the ability of insects to migrate into the building structure.

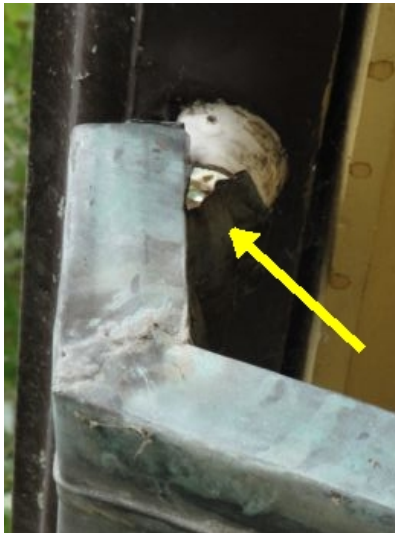
- There are areas noted where the downspout was improperly connected to the gutter, which could allow moisture to build up and rot the exterior paneling. IMPROVE: Re attach these connection points as necessary.

Disconnected downspout

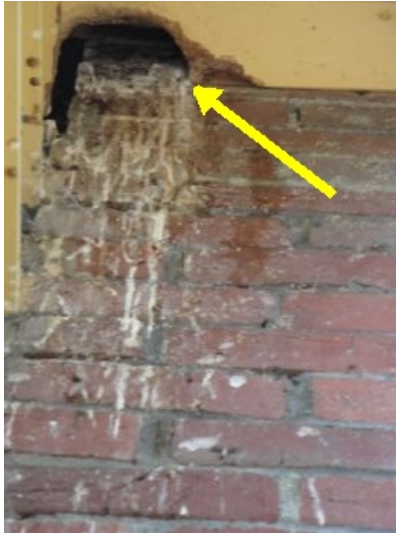
- There was a large hole in the soffit against the South/East chimney where birds have made a home. Recommendation: Contact a pest control company to discuss options for removal. Repair holes in the soffit to prevent future pest/water intrusion.

Soffit damage & evidence of nesting birds

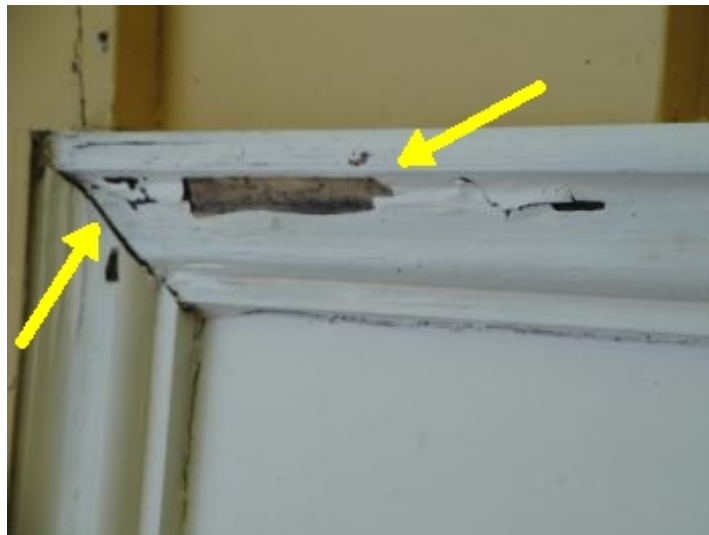
- There is no head flashing above the exterior windows or doors. Although window & door flashings may not have been recommended at the time the house was built, I suggest the installation of these head flashings, especially in areas where the doors and windows are not protected by large overhangs.
- There was evidence of wood rot on the trim of the north west corner of the house. Recommendation: Replace as necessary and repaint with a water resistant paint.

Wood rot on the garage door trim

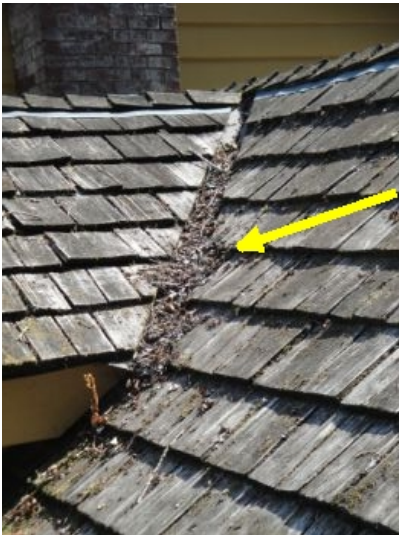
- There were areas of moss growth, debris and damaged shingles throughout the roof surface. Recommendation: Remove all debris & moss from roof surface. Maintain a clean roof surface to increase its longevity.
- The roof is old, in need of repair, within last few years of useful lifespan. Recommendation: Budget for a new roof in the near future.

Debris in roof valley

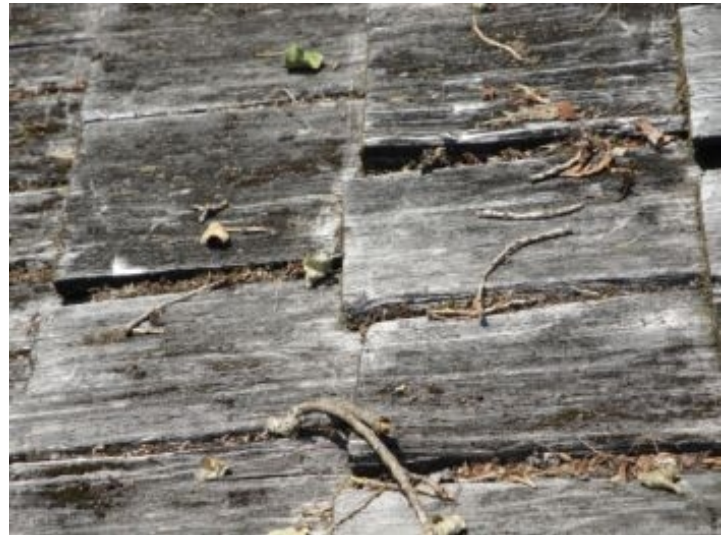
Damaged, old roof shingles

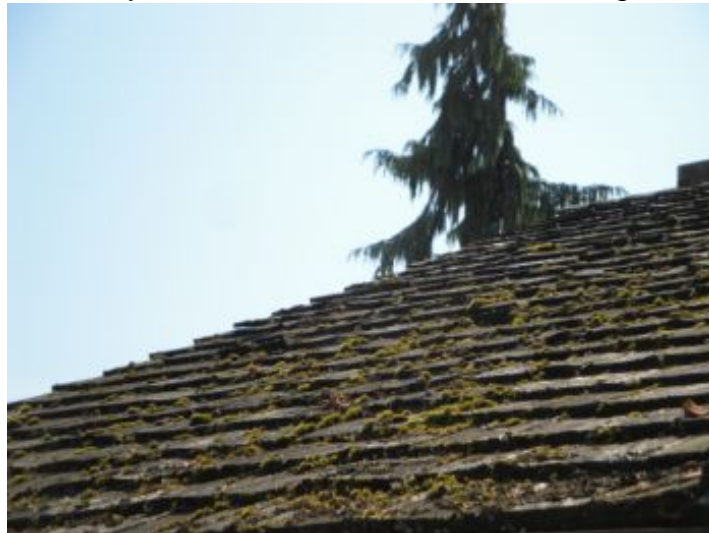
Extreme moss growth on roof

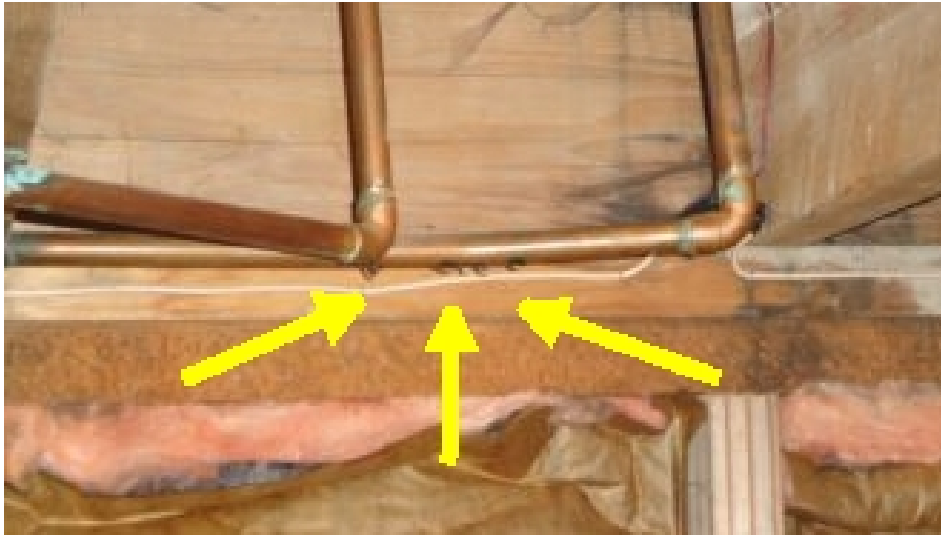
- Evidence of leaking pipes in crawlspace and under kitchen sink. Monitor and repair as necessary.
- Small pinhole leaks on copper pipes in crawlspace. Recommendation: Contact a plumber to further investigate.

Pinhole leaks in Copper piping

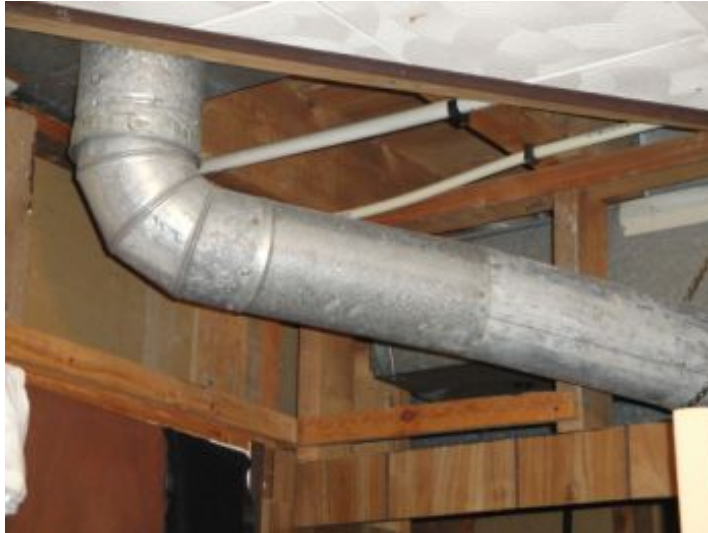
- **SAFETY CONCERN:** Chimney flue/vent pipe has inadequate clearance to combustible materials. Repair as needed.

SAFETY CONCERN: Chimney flue/vent pipe has inadequate clearance to combustible materials.
Repair as needed

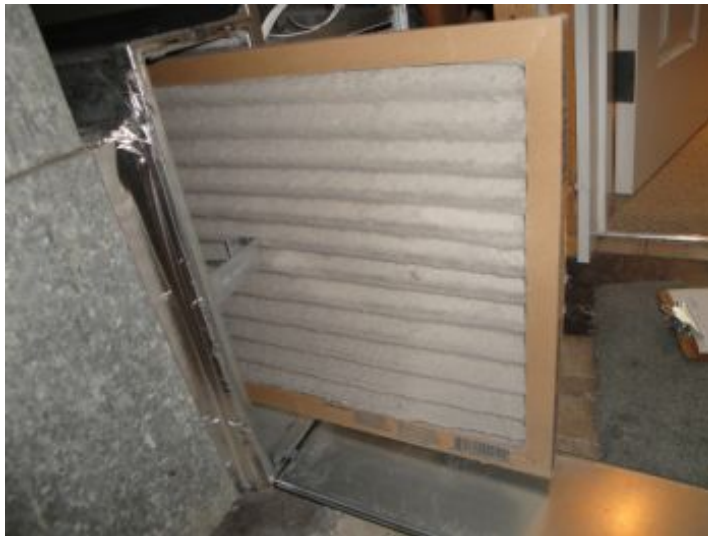
- Filter is clogged and dirty. Recommendation: Replace filter as soon as possible and each 3 months to ensure air quality.

Dirty filter needs to be replaced

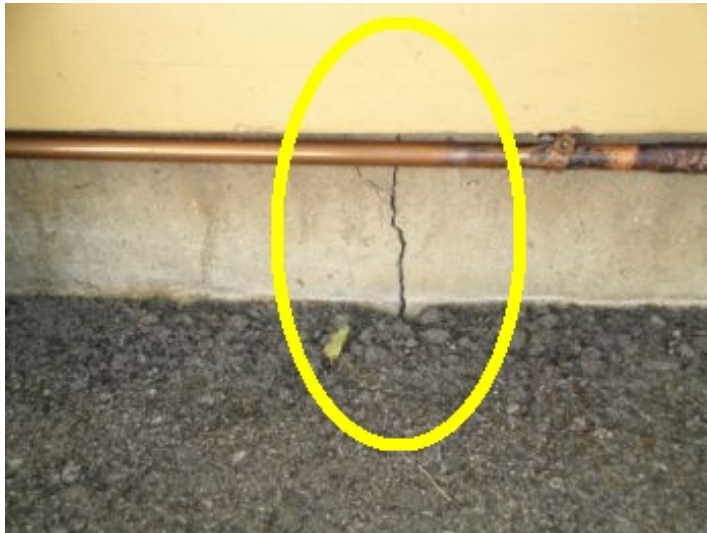
- There was a small settlement crack on the South/West side of the garage foundation wall. Recommendation: Seal crack with a readily available Epoxy sealant according to manufacturers instructions.

Small crack in the foundation wall, south side

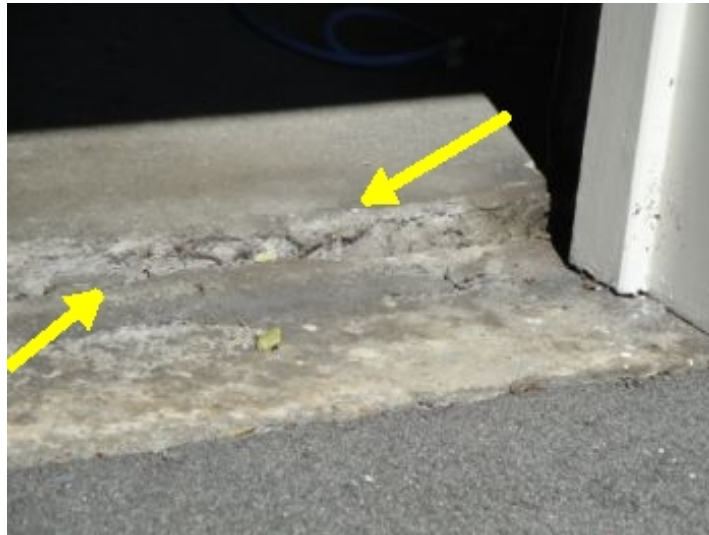
- Minor settlement cracks in the concrete, which is typical for a house of this age and wear.

Settlement crack

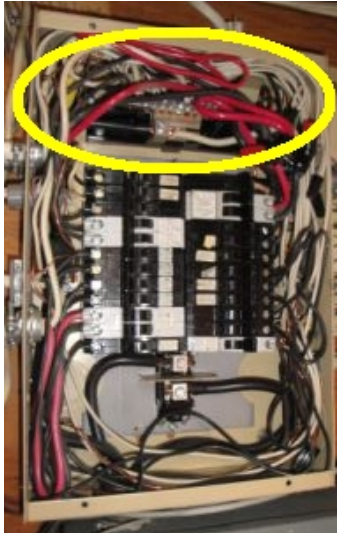
- **SAFETY CONCERN:** The main service panel is crowded, which could lead to a possible fire safety hazard. Recommendation: Contact a licensed electrician to repair the issue as needed.

Electrical panel is crowded

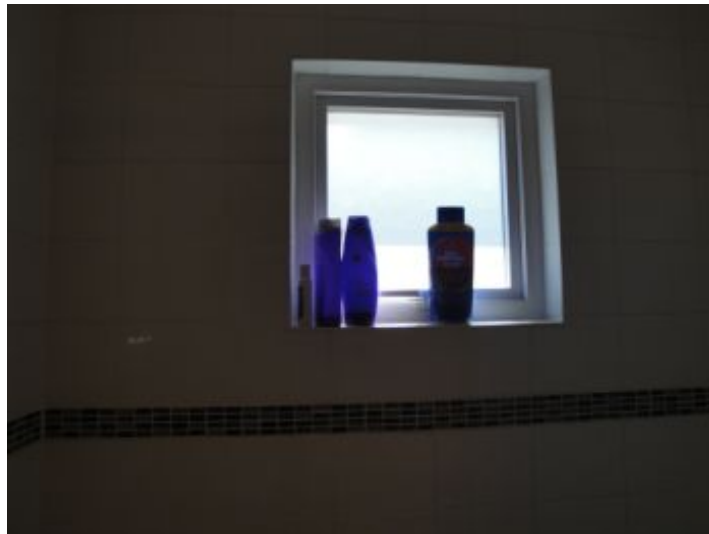
- Windows in bathroom showers are not recommended. Although they are a source for natural light, they can also contribute to moisture build up. Items left on the window sill will also hold moisture to the surface which can lead to wood rot. Recommendation: Install a curtain across the window when shower is in use and remove items from the window sill.
- There were high level moisture readings noted on the ceramic tiles surrounding the shower taps. As noted, there is a possibility of moisture damage and/or mold to the structure behind. Recommendation: Consult a licensed plumber/contractor for further evaluation.

Windows are not recommended in bathroom shower

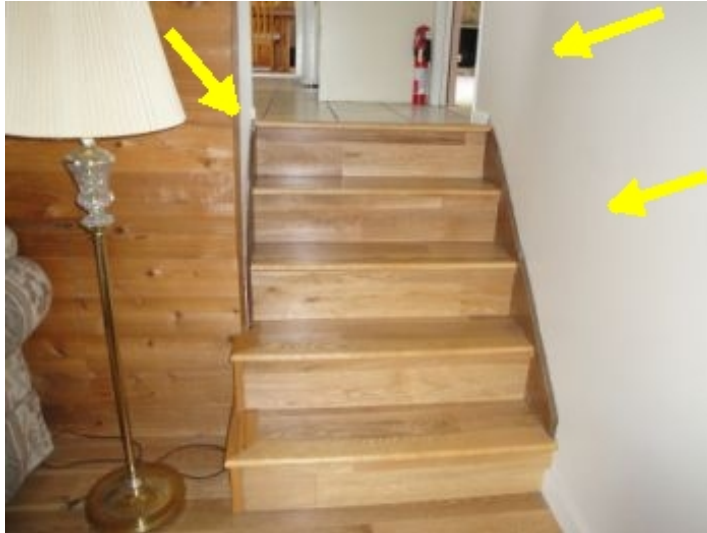
- **SAFETY CONCERN: Missing handrail on stairs leading to second floor. Hand rails must be installed on all stairways with more than 3 stairs.**

Missing hand rail up to kitchen, safety concern
